DEPARTMENT OF TRANSPORTATION

Quality Assurance and Source Inspection

Contract #: 04-0120F4Cty: SF/ALA Rte: 80 PM: 13.2/13.9File #: 1.28**WELDING INSPECTION REPORT****Resident Engineer:**Siegenthaler, Peter**Address:** 333 Burma Road**City:** Oakland, CA 94607**Report No:** WIR-023888**Date Inspected:** 18-May-2011**Project Name:** SAS Superstructure**OSM Arrival Time:** 730**Prime Contractor:** American Bridge/Fluor Enterprises, a JV**OSM Departure Time:** 1600**Contractor:** American Bridge/Fluor Enterprises, a JV**Location:** Job Site**CWI Name:** Steven McConnell**CWI Present:** Yes No**Inspected CWI report:** Yes No N/A**Rod Oven in Use:** Yes No N/A**Electrode to specification:** Yes No N/A**Weld Procedures Followed:** Yes No N/A**Qualified Welders:** Yes No N/A**Verified Joint Fit-up:** Yes No N/A**Approved Drawings:** Yes No N/A**Approved WPS:** Yes No N/A**Delayed / Cancelled:** Yes No N/A**Bridge No:** 34-0006**Component:** S.A.S. components**Summary of Items Observed:**

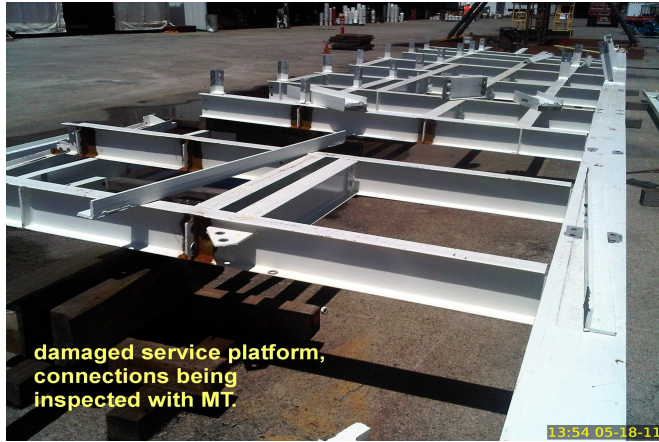
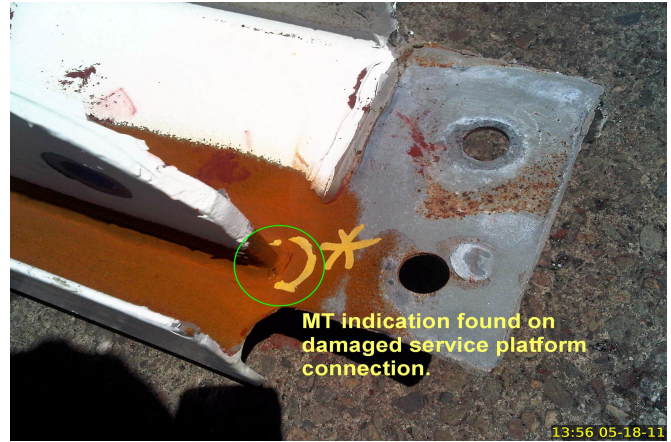
The QAI was informed that the contractor is planning to repair a service platform that was damaged during shipment. The QAI met with the Quality Control Inspector (QCI) Steven McConnell and was informed that the repair plans have not been determined at this time. The QCI informed the QAI that magnetic particle testing (MT) has been performed on connections that within the damaged areas of the service platform. The QAI noted that the paint has been removed from welded connections to facilitate the MT. The QAI was informed that there were areas marked for paint removal that were not examined. The QCI remarked that additional paint removal was necessary before the MT examinations can be completed. The QAI was informed that several relevant indications were observed during the partial MT. See the attached photos. The QCI also informed the QAI that there were several members of the service platform that could not be located. The QAI was informed that the MT reports would be submitted and that there has not been a schedule developed for the remaining inspections and / or repairs of this service platform.
